**ABU GHRAIB DAIRY
ABU GHRAIB, IRAQ**

**SIGIR PA-09-172
JANUARY 14, 2009**

Abu Ghraib Dairy

Summary of Report: PA-09-172

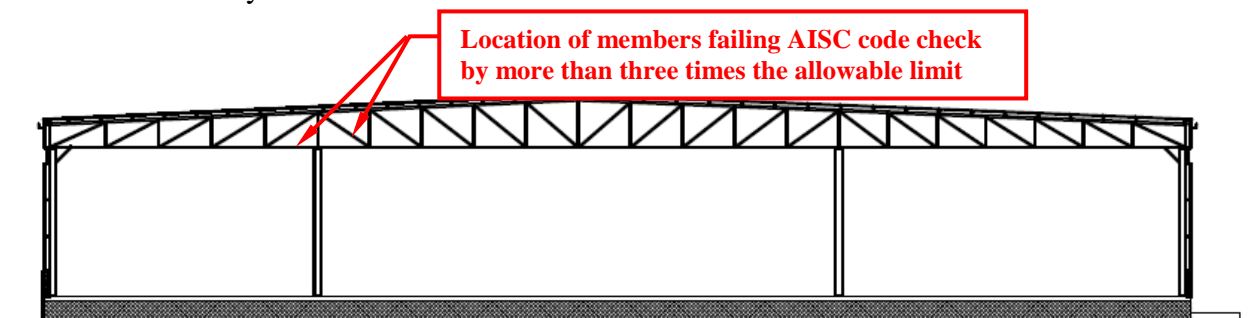
Figure 2. Primary truss configuration

- Based on the contractor's calculations, five members of the truss were designated as failing the AISC code check. Two of the members failed the code check by more than three times the allowable limit (Figure 2). Failing by a factor of this magnitude indicates that the members could yield and possibly fracture under the design load.

The contractor's proposed structural design consists of steel columns and continuous truss construction with sandwich panel cladding¹⁸ for the roof and sidewalls. Roof loads are carried by the multi-span steel trusses, which have two configurations. The primary configuration has steel columns supporting the truss at the ends and at approximately one-third span (Figure 2). The columns are centered on a truss panel point (the location of intersecting truss members), which is appropriate. Based upon the contractor's drawings, it appears that the member sizes have been modified to accommodate the stress reversal¹⁹ over only one of the interior columns.

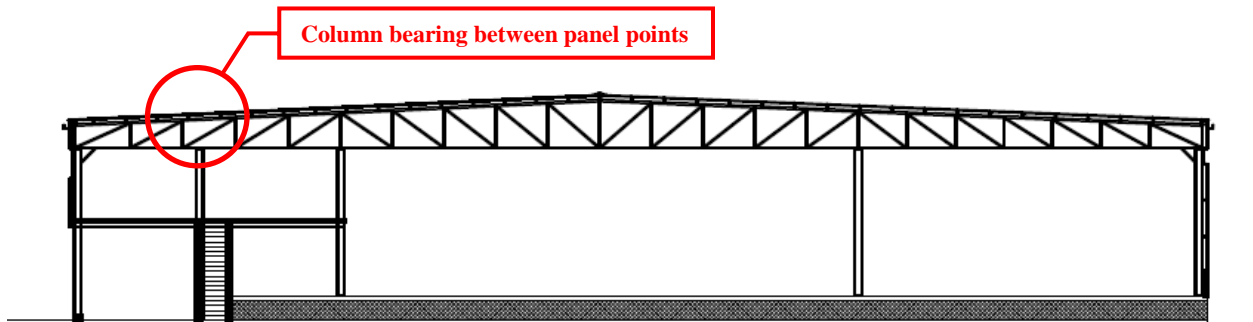
Figure 3. Truss configuration at mezzanine level

In the area of the mezzanine, the plans show additional columns (Figure 3), which extend through the mezzanine to the underside of the truss. The additional bearing locations provided by these columns are not at a truss panel point. The resulting reactions from these columns will introduce bending into the lower chord of the truss. SIGIR is

concerned that the members used in the lower chord of the truss are relatively light and do not appear to have the capacity to resist a significant amount of bending stress in addition to the compressive load that will result from the intermediate support.

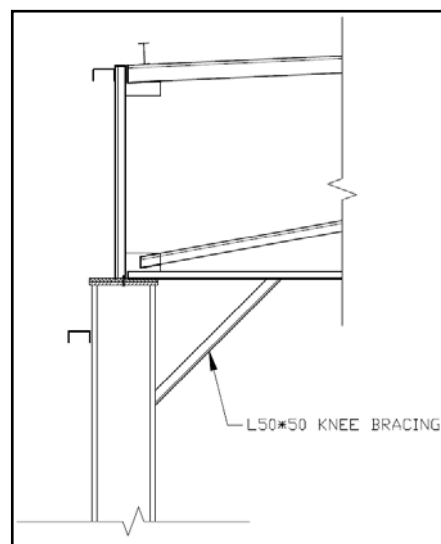
Figure 4. Knee brace detail

The contractor's design drawings do not address the method used to resist lateral loads parallel to the building's gable. It appears that the design incorporates diagonal cross bracing between several bays in the direction parallel to the ridge; however, there is no indication of bracing parallel to the gable (slope). In addition, the building's use of column and truss construction requires additional consideration of lateral loads. The only members that appear to be placed to provide lateral stability in the axis of the gable are the diagonal knee braces (Figure 4). These knees appear to be severely undersized, considering their location and configuration.

If the braces are used to resist lateral loads, the connection between the columns and truss would become, at least, partially fixed. This would introduce significant load into the lower chord of the truss, which appears to be already undersized. Fixing the truss/column connection would also introduce a lateral component into the column reaction; special consideration would then be required in the design of the foundation to resist this load.

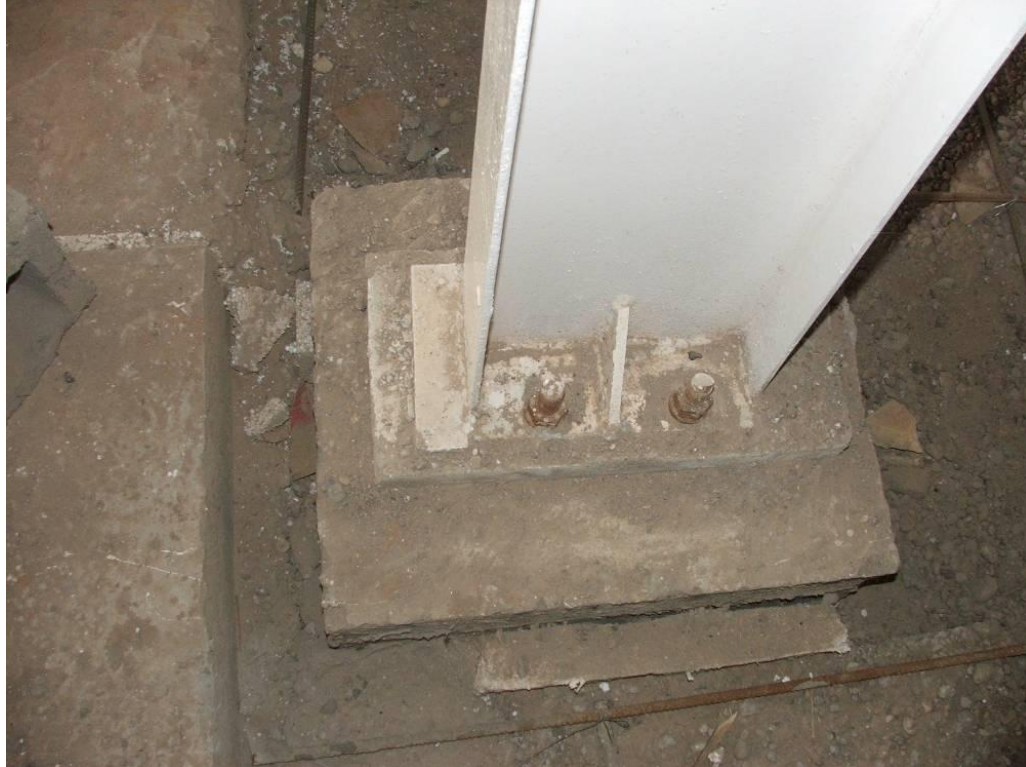
At the time of the site visit, the foundations for the facility were installed. The foundation system appeared to be concrete pedestals with steel anchor bolts attached to the base plates of the steel columns (Site Photo 1). The foundation system also included spread footings to support the concrete pedestals and columns. Since the foundation was in the later stages of construction, only the upper portion of the foundation was exposed for inspection; consequently, SIGIR could not verify the construction of the foundation.

Site Photo 1. Typical foundation pedestal and anchor bolts

SIGIR observed no visible displacement of the foundation system; however, at the time of the site visit, the building was not complete and the footings were not fully loaded. Significant foundation settlement, if it were to happen, would not occur until after completion of construction.

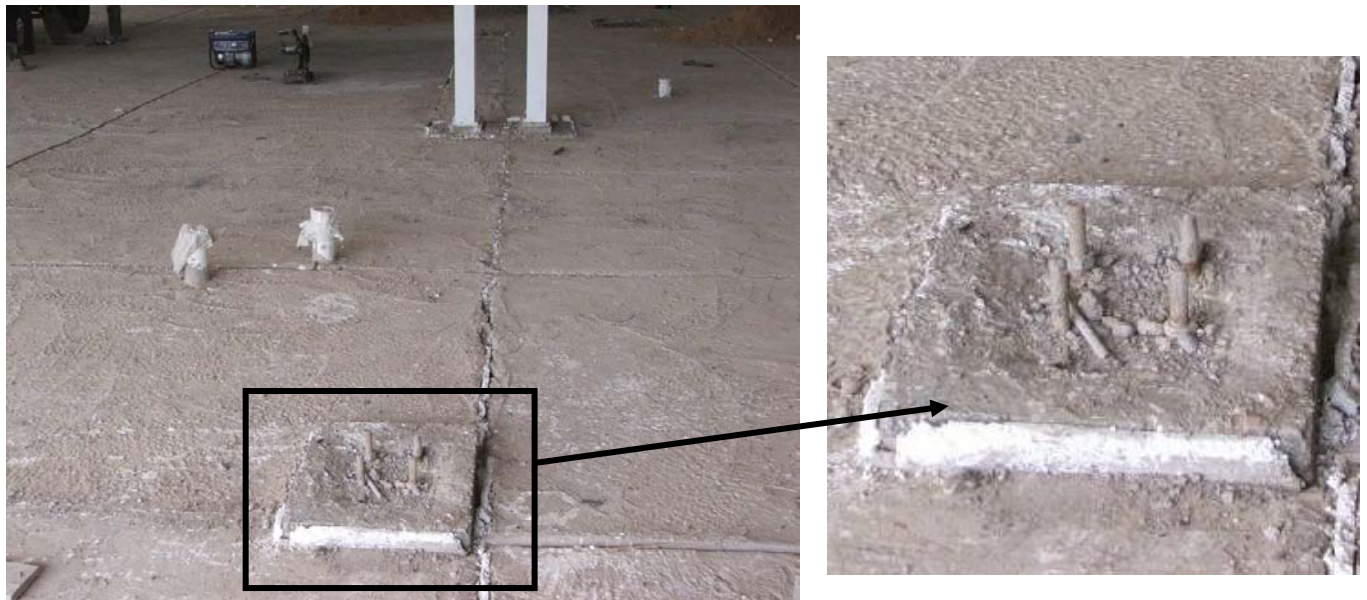
SIGIR noticed several sets of anchor bolts not attached to structural columns (Site Photo 2). The contractor's project manager stated that these anchor bolts are intended to attach the mezzanine columns to the foundation. It appears that the contractor did not adequately protect the anchor bolts during construction of the concrete slab, since SIGIR observed bolts coated with concrete and, in some cases, bolts that had been bent. These bolts may be damaged to the point that the mezzanine columns cannot be placed over the bolts without modification to the base plate or re-bending the bolts. The concrete-coated bolts require cleaning, and if the underlying threads are damaged, they may require re-threading to accept a nut to secure the base plate.

Site Photo 2. Unprotected, exposed anchor bolt group

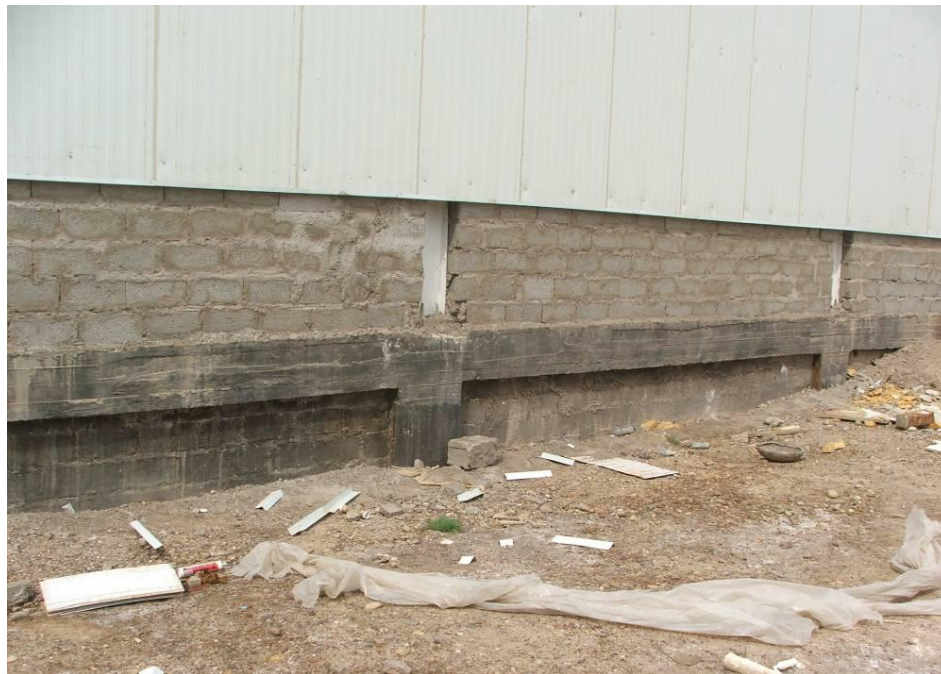
The foundation system included a perimeter concrete masonry unit (CMU) wall (Site Photo 3), which acts as a grade separation barrier and contains the backfill beneath the floor slab in the building. Due to a construction error, the CMU wall was not constructed on the exterior of the steel framing; rather it has been constructed between the steel columns. This created several issues with the structure that need to be addressed.

Site Photo 3. Perimeter CMU wall

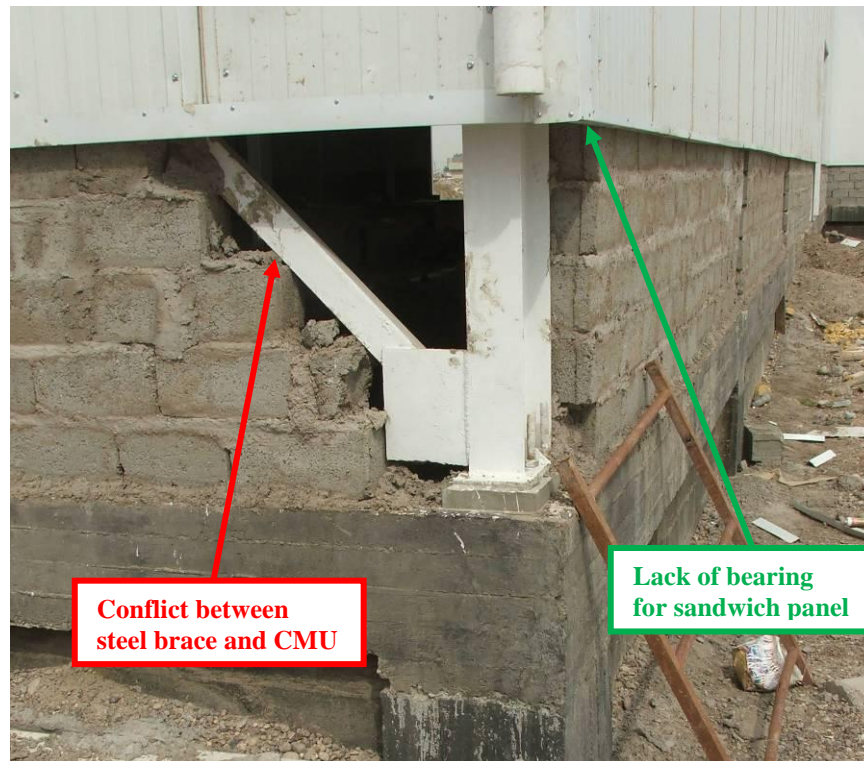
The CMU wall interferes with the steel cross bracing between several of the columns (Site Photo 4). It appears as if the contractor's solution to this issue was to lay the CMU wall around the bracing and coat the entire area with plaster. However, this approach may cause future problems as the steel bracing moves independently of the CMU wall causing recurrent cracking at the location.

Site Photo 4. Cross brace conflict with CMU perimeter wall

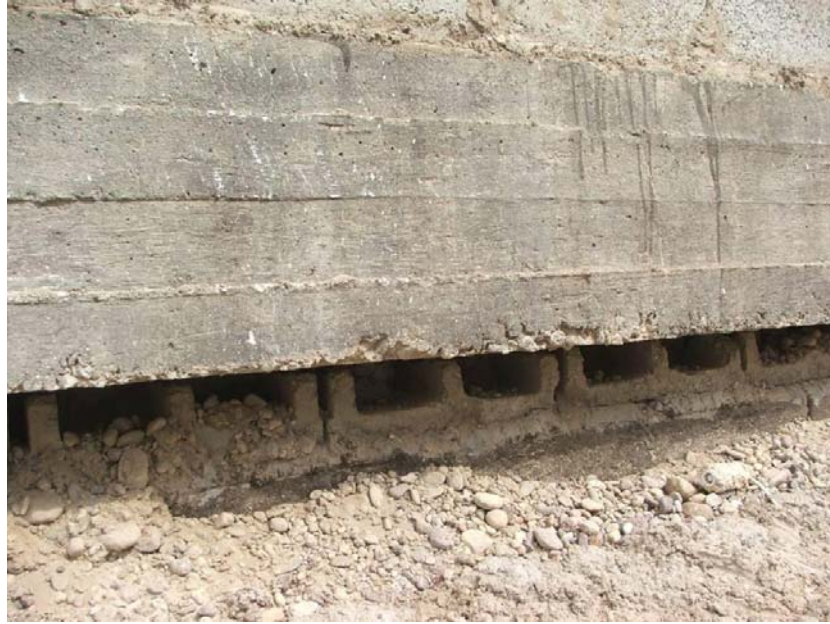
Site Photo 5. Course of CMUs placed with cores horizontal

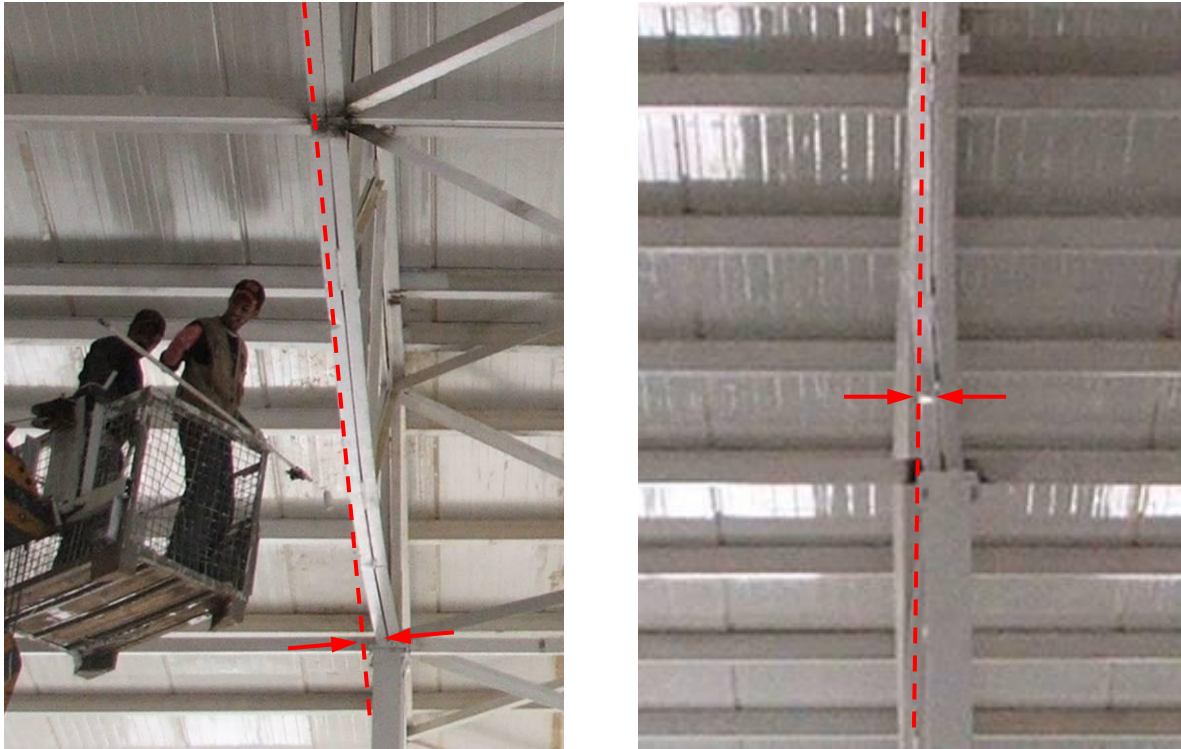
SIGIR noticed deformation (buckling/bending) of several of the roof trusses near one of the interior column lines (Site Photos 7 and 8). Due to the limited time available on site and the lack of aerial access to the steel framing, SIGIR could not determine the magnitude of the displacement; however, the fact it could be detected visually from the ground level indicates that the displacement is significant.

Site Photos 7 and 8. Lateral bow in lower truss chords

Based on the contractor's calculations, the lower chord members adjacent to the interior column are overstressed and are unable to support the design load. The truss is a continuous truss, which results in compression loads in the members. A compression failure of the lower chord could result in buckling of the chord and lateral displacement. This corresponds with the behavior of the lower chord SIGIR observed. While the contractor's calculations indicate that the displacement may be indicative of the initial stages of truss failure, other factors may also have contributed to the misalignment, such as poor construction techniques used during the erection of the trusses or "adjustment" of the trusses during installation of the bracing. Either scenario could have further amplified any deformation of the trusses.

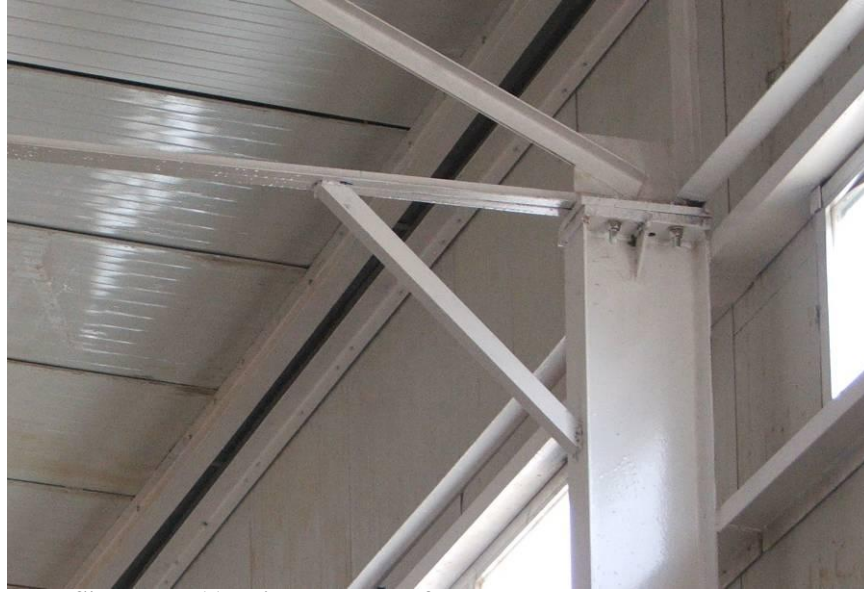
To provide lateral bracing parallel to the trusses, diagonal braces were welded to the steel columns and the lower chord of the truss (Site Photo 11). SIGIR observed what appeared to be significantly undersized braces in place, which could lead to excessive bending in the lower chord of the truss.

Site Photo 11. Diagonal brace from column to truss lower chord

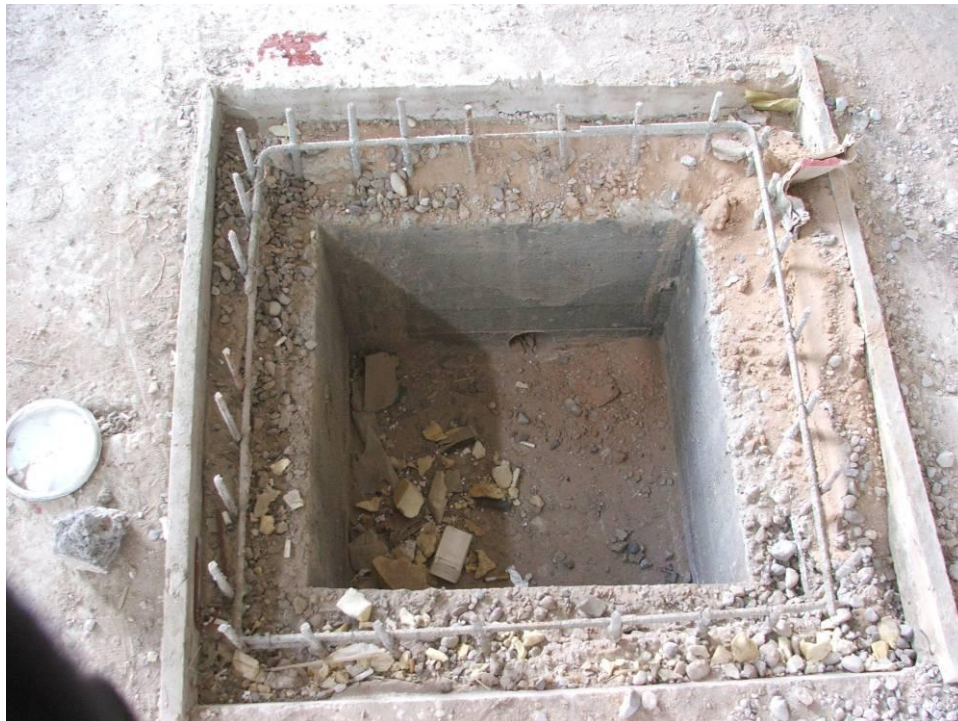
SIGIR observed sanitary sewer manholes in several locations in the floor (Site Photo 12). The sanitary manholes were constructed as cast-in-place reinforced concrete with polyvinyl chloride sewer piping cast directly into the manhole walls. The contractor failed to install a manhole on the interior of the building; instead the contractor installed a polyvinyl chloride elbow. This will result in future problems because the sewer line is not accessible for cleaning.

Site Photo 12. Cast-in-place sanitary sewer manhole

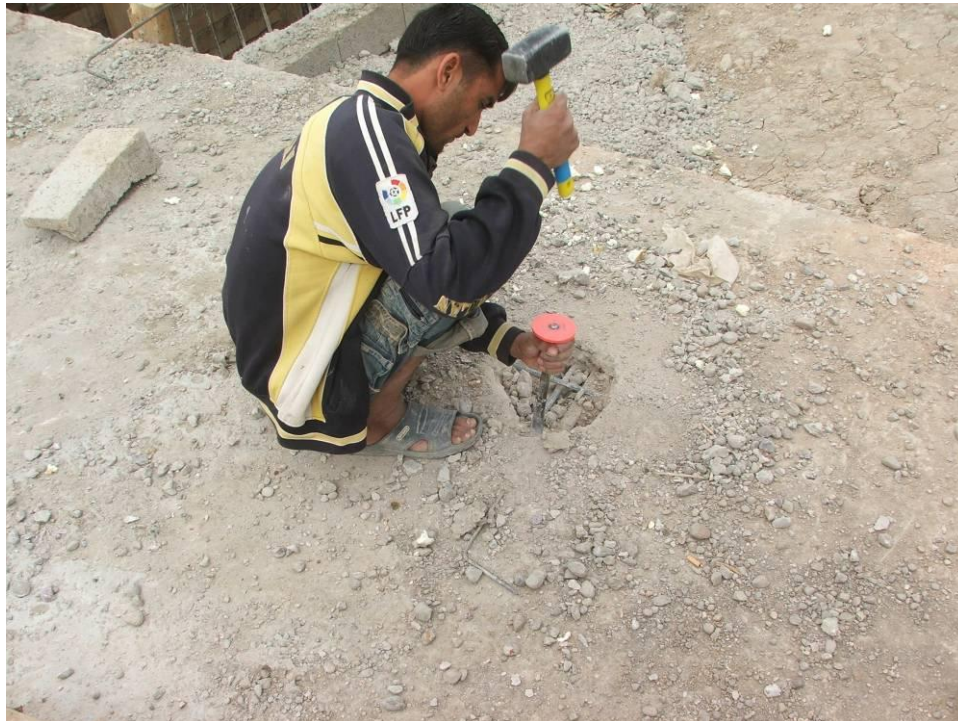
Site Photo 13. Chiseling tank lid for pipe penetration

The contractor did not cast the vent pipe penetrations into the tank lid at the time of construction; rather the contractor is attempting to install the vent pipes after completion of the lid. This construction technique requires chiseling of the concrete, cutting the

reinforcing steel, and grouting the pipe in place. This “modification” weakens the lid and creates increased potential for leakage.

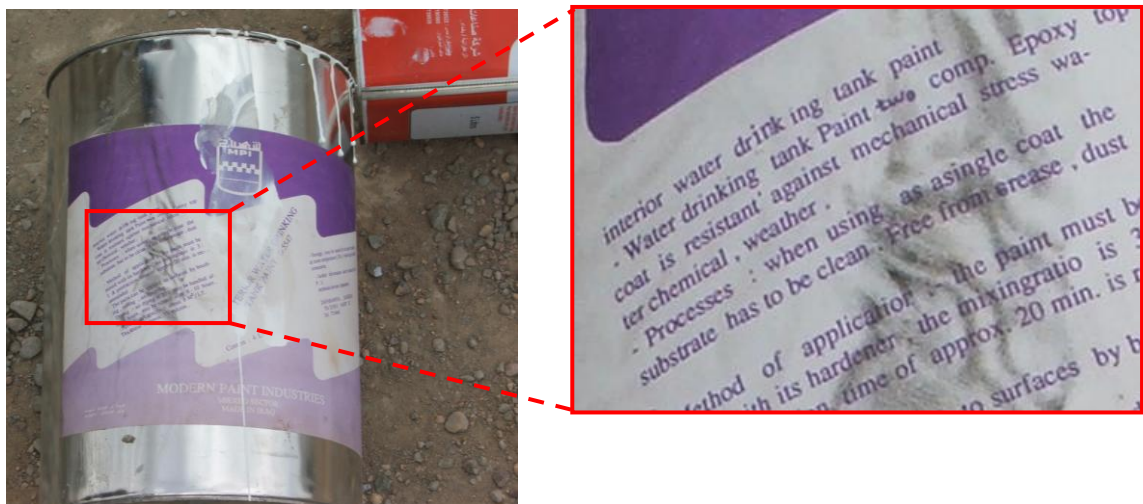
SIGIR observed the contractor applying coatings to a liquid tank’s interior. The labels on the coating containers (Site Photo 15) stated that the coatings were two-part epoxy and the material was compatible for use with potable water.

Site Photo 15. Coating for potable water tank

In addition, the QA representatives did not identify safety concerns. For example, during the first site visit, SIGIR detected harsh fumes from the use of two epoxy coatings for a liquid tank. SIGIR observed the workers applying the coatings to the tank’s interior with no protective equipment or breathing apparatus. SIGIR is concerned that prolonged exposure to the fumes in the enclosed environment (of the tank) could lead to significant health problems.

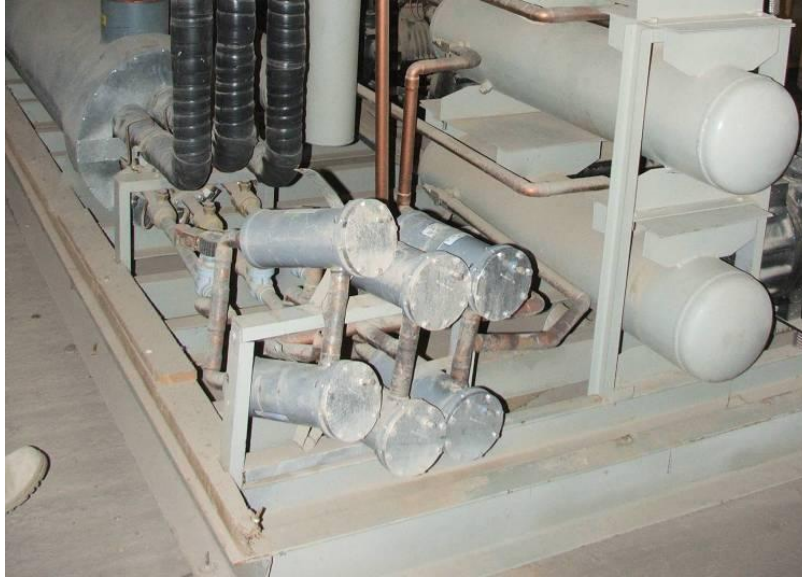
With the exception of one large piece of equipment already located inside the newly constructed facility, the milk processing and packaging equipment is stored inside a leaking warehouse²³ near the Abu Ghraib Dairy (on the Ministry of Industry and Minerals compound). SIGIR toured the warehouse and found most of the equipment in its original packaging and appeared to be in good condition. One of the pieces of equipment sustained some damage due to either improper storage or handling (Site Photo 16). SIGIR was able to identify several pieces of equipment with visible nameplates (Site Photo 17), and the remainder of the equipment was labeled with shipping labels.

Site Photo 16. Damaged dairy production equipment

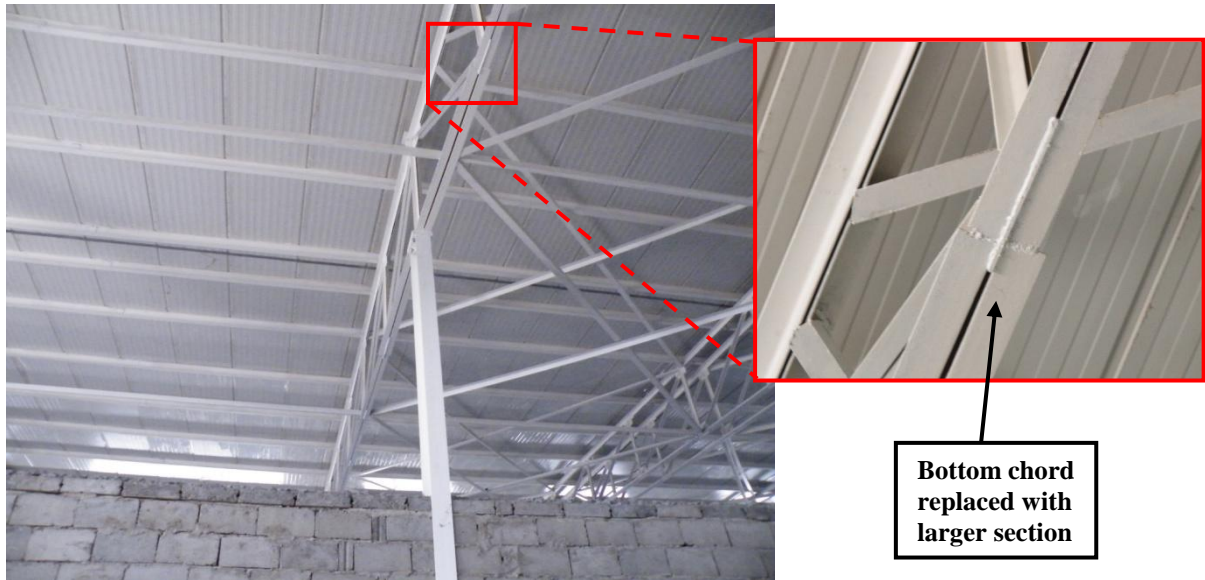
it was inadequate and replaced it with a larger section. Aerial lift capabilities were not available at the time of the site visit; therefore, a hands-on inspection of the repair could not be made. However, SIGIR was able to verify that the trusses had a larger bottom chord section in the areas previously noted as deficient (Site Photo 18).

Site Photo 18. Contractor's truss modification

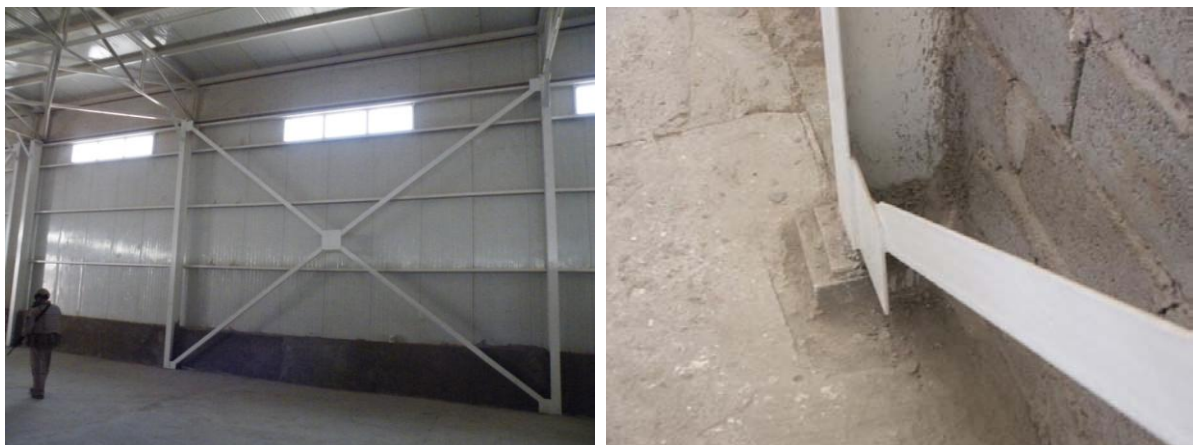
Previously, SIGIR noted that due to the contractor's deviation from the design drawings, the steel cross bracing for the structure conflicted with the CMU perimeter wall. To correct this, the contractor removed the CMU wall, relocated the steel cross bracing to the interior of the wall, and reconstructed the wall (Site Photos 19 and 20).

Site Photos 19 and 20. Cross bracing located to perimeter CMU wall interior

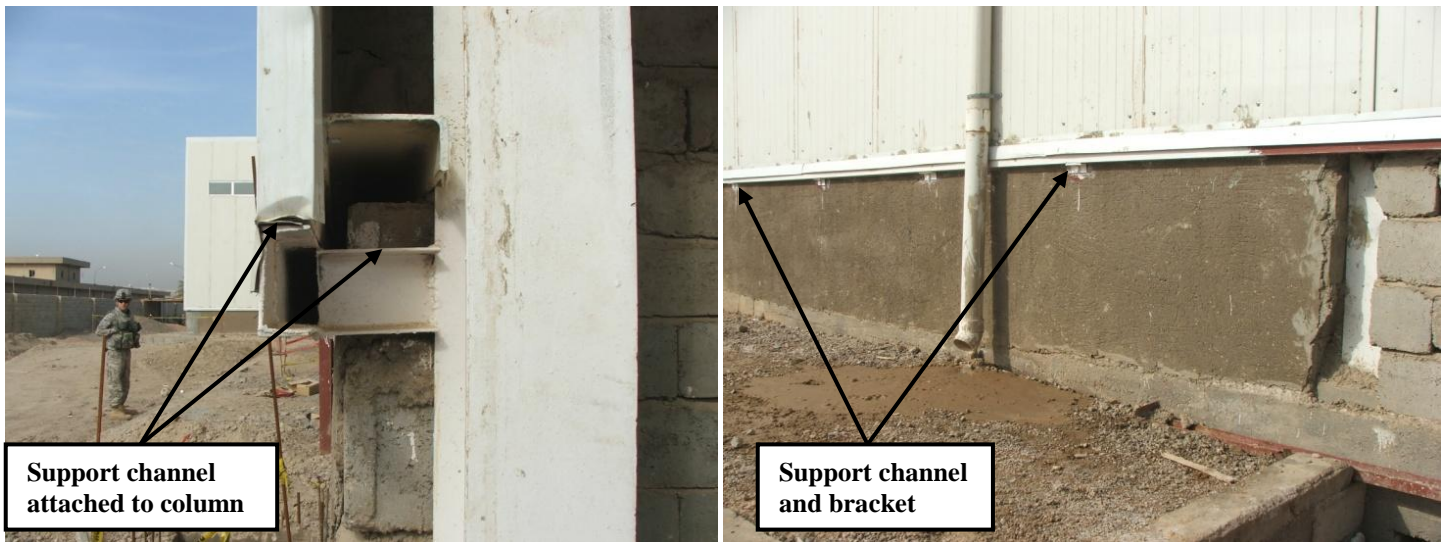
Another previously noted deficiency was the lack of support for the sandwich panels used as cladding for the building exterior. This lack of support was due to the contractor's deviation from the original design, which located the perimeter CMU wall to the interior of the steel framing. To remedy this situation, the contractor installed steel channels

around the perimeter of the building attached to the columns and supporting the panels (Site Photos 21 and 22).

Site Photos 21 and 22. Support channel for sandwich panel

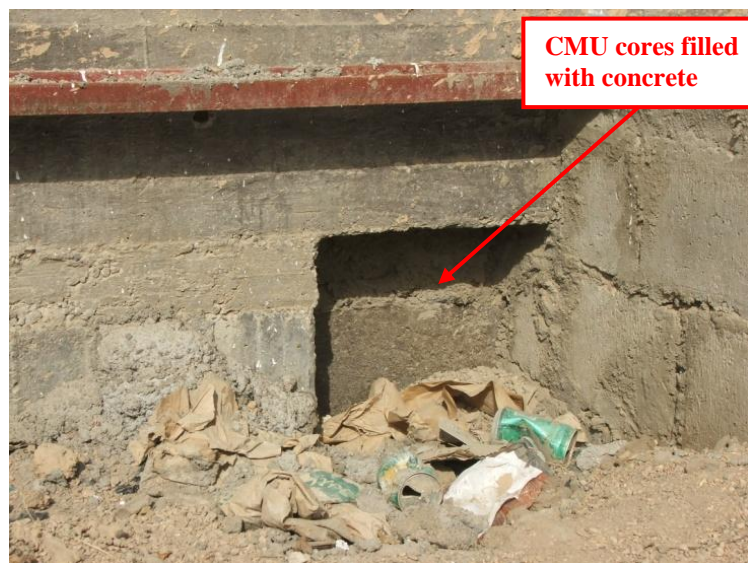
Initially, the contractor incorrectly placed CMUs with their sides' horizontal along the foundation wall. This orientation significantly weakened the CMUs. The contractor corrected this deficiency by using concrete to fill the cores of the CMUs, which provides increased strength to the wall (Site Photo 23).

Site Photo 23. CMU cores filled with concrete
